2018年2月号安全談話室 添付図

Title of material: **How a pipe failure resulted in resizing vessel emergency relief stems** (pages 48–56)

Title of book/journal: **Process Safety Progress** March 2003 Volume 22, Issue 1

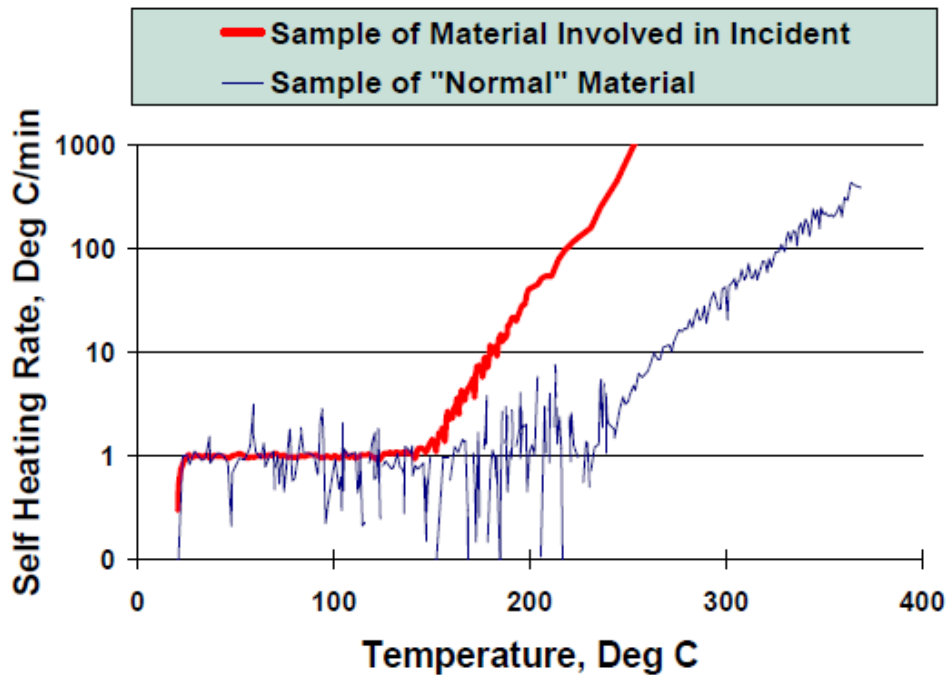
Figure 10: VSP test results from sample of material collected from Pipe C compared to “normal” residue sample
